ASBESTOS MATERIALS ASSESSMENT

Sunshine College Campus 4

8 June 2015

Subject: Asbestos Materials Assessment Sunshine College Campus 4, Northumberland Road, Sunshine North (Site 7575)

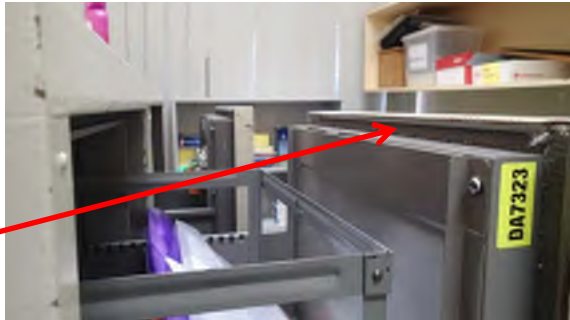
Photograph 1. Rope lining to fireproof filing cabinet. 57 Resource, Commerce Wing (DA7323). **Asbestos Detected.**

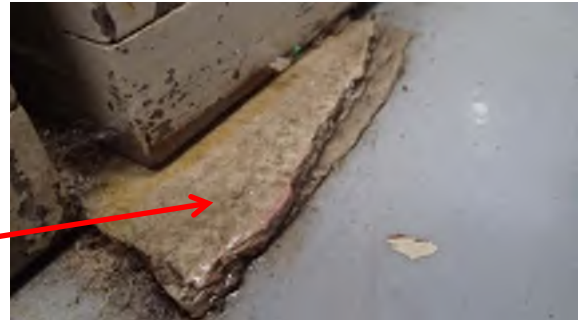
Photograph 2. Cement sheet packers. 57 Resource, Commerce Wing (Visual Observation). **Asbestos Presumed.**

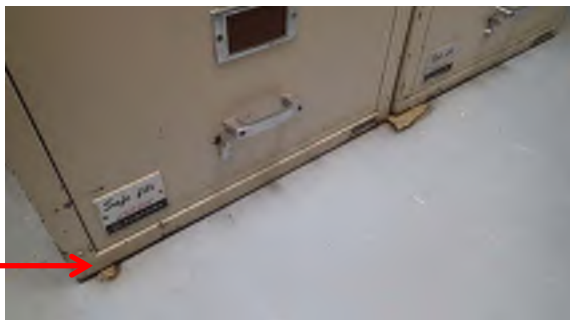
Photograph 3. Cement sheet debris. 57 Resource, Commerce Wing (Visual Observation). **Asbestos Presumed.**

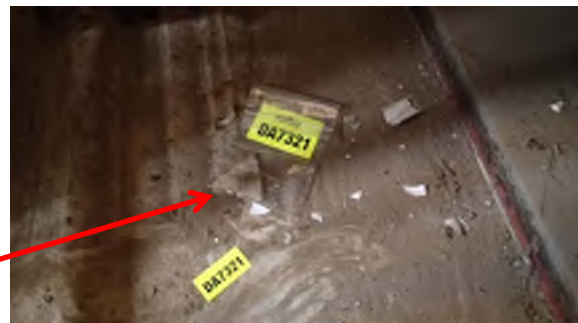
Photograph 4. Cement sheet debris. Commerce Wing, 264 Store (DA7321). **Asbestos Detected.**

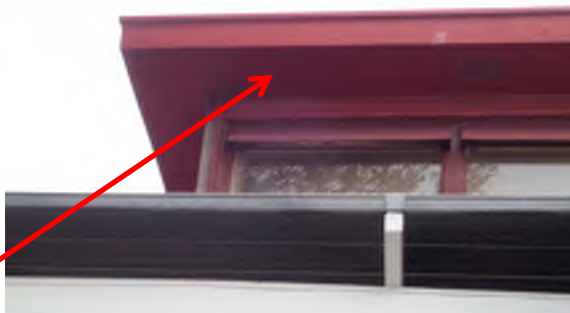
Photograph 5. Cement sheet clear storey eaves. External, Commerce Wing (Refer to 33538-270). **Asbestos Detected.**

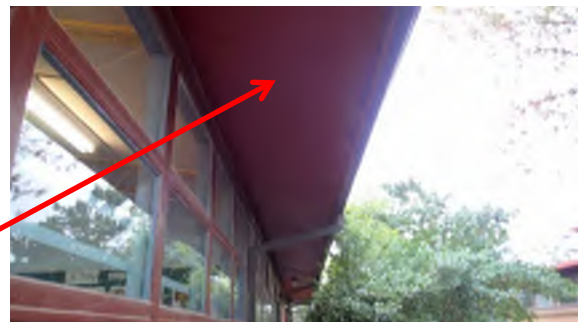
Photograph 6. Cement sheet eaves. External, Commerce Wing (Refer to 33538-275). **Asbestos Detected.**

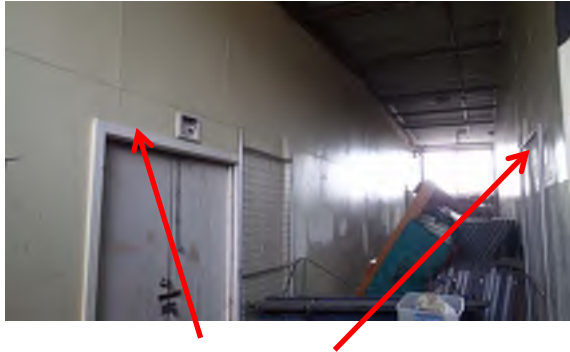
Photograph 7. Cement sheet walls. 64 Prop Store, Multi-Purpose Hall (Refer to 33538-147). **Asbestos Detected.**

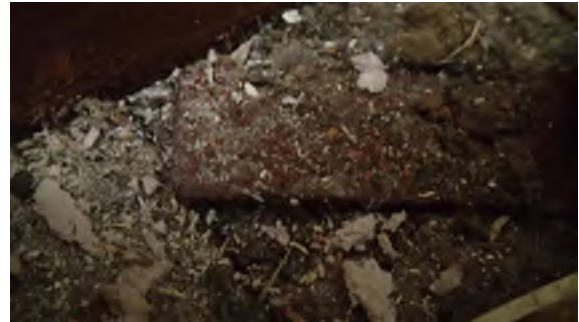
Photograph 8. Cement sheet debris. 64 Prop Store, Multi-Purpose Wing (DA7325). **Asbestos Detected.**

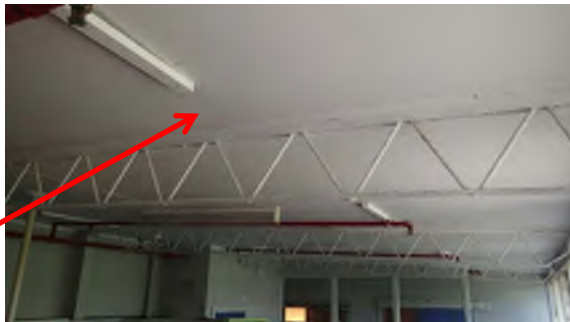
Photograph 9. Cement sheet ceiling. 65 Male Change, Multi Purpose Hall (Refer to 33538-139) **Asbestos Detected.**

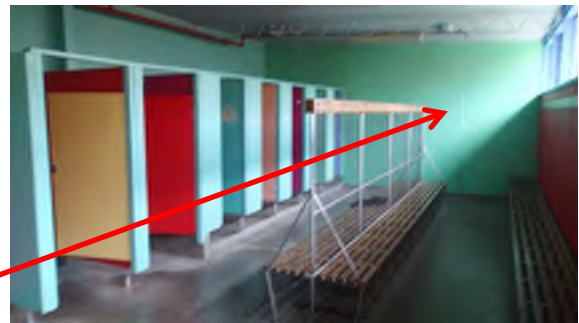
Photograph 10. Cement sheet walls. 66 Female Change, Multi Purpose Hall (Refer to 33538-162) **Asbestos Detected.**

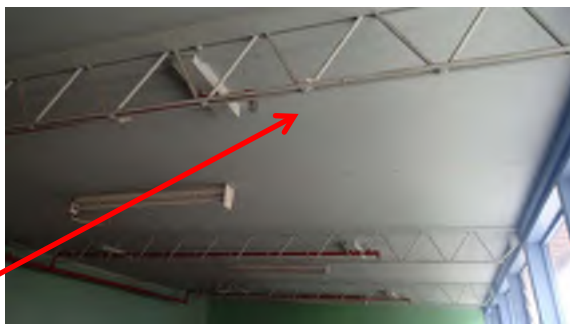
Photograph 11. Cement sheet ceiling. 66 Female Change, Multi Purpose Hall (Refer to 33538-164). **Asbestos Detected.**

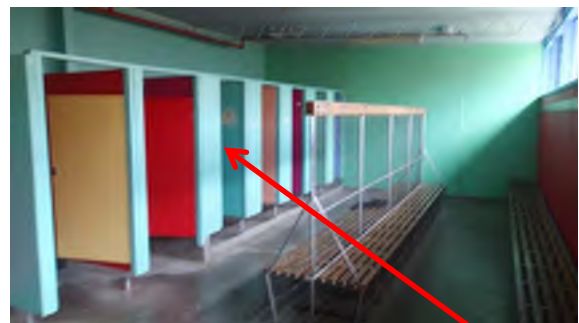
Photograph 12. Cement sheet cubicle partitions. 66 Female Change, Multi Purpose Hall (Refer to 33538-163). **Asbestos Detected.**

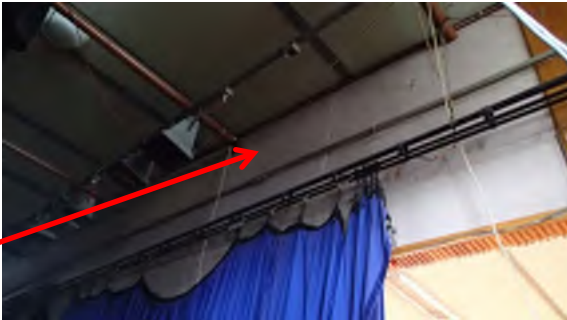
Photograph 13. Cement sheet infill panel. 67 Platform, Multi Purpose Hall (Refer to 33538-152). **Asbestos Detected.**

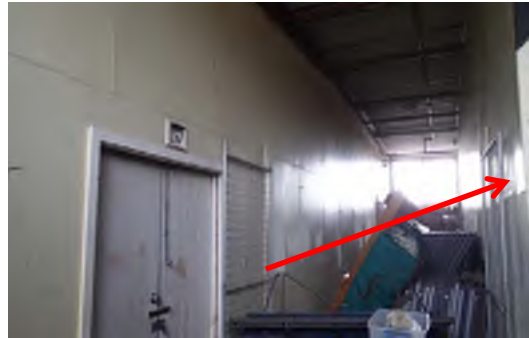
Photograph 14. Cement sheet partition wall. 67 Platform, Multi Purpose Hall (Refer to 33538-153). **Asbestos Detected.**

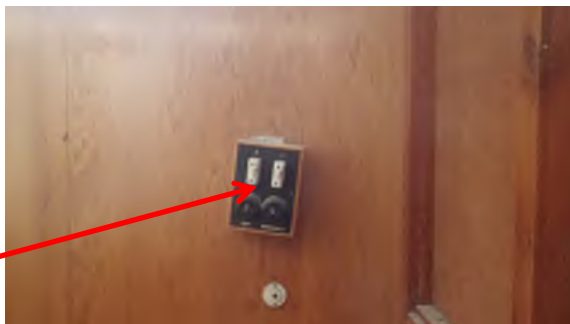
Photograph 15. Electrical backing board and fuse lining. 67 Platform, Multi-Purpose Hall (Visual Observation). **Asbestos Presumed.**

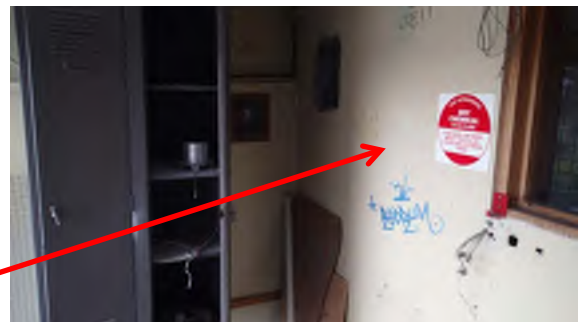
Photograph 16. Cement sheet walls. 69 Steps, Multi-Purpose Wing (Refer to 33538-155). **Asbestos Detected**

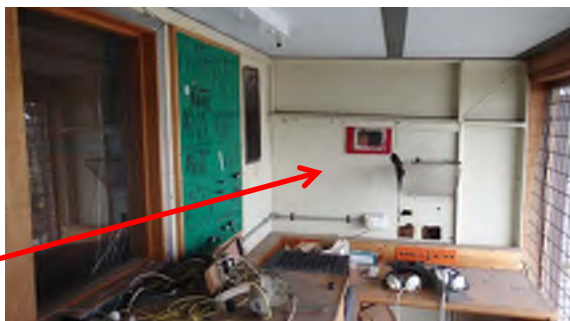
Photograph 17. Cement sheet walls. 69 Steps (room Above), Multi Purpose Hall (Refer to 33538-155). **Asbestos Detected.**

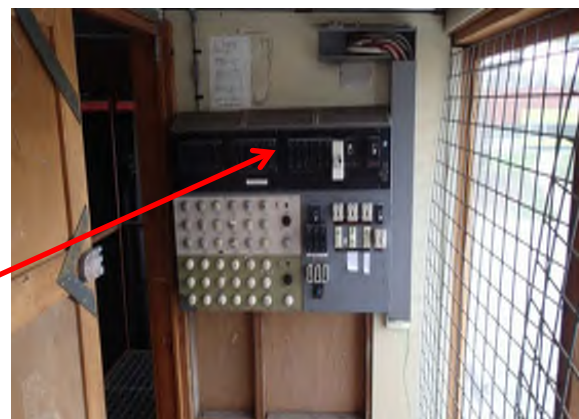
Photograph 18. Electrical backing board. 69 Steps (room Above), Multi Purpose Hall (Visual Observation). **Asbestos Presumed.**

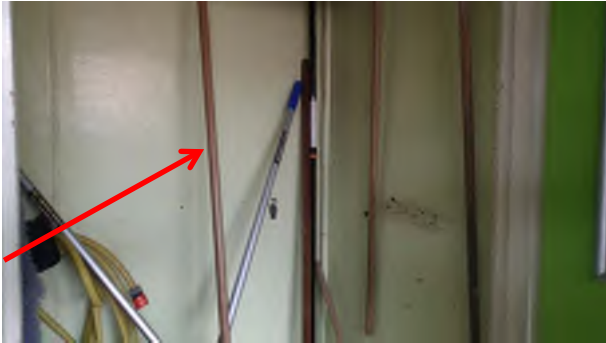
Photograph 19. Cement sheet walls. 71 CLNR, Multi Purpose Hall (Refer to 33538-160). **Asbestos Detected.**

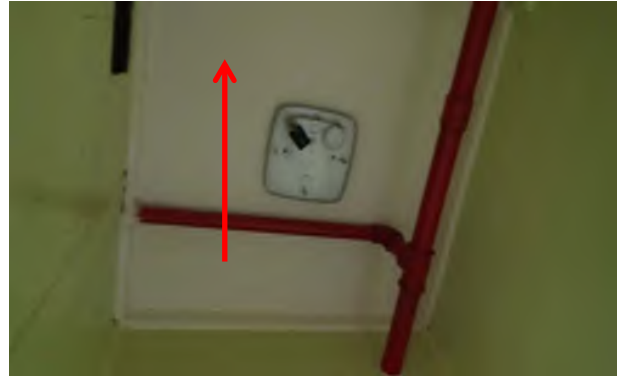
Photograph 20. Cement sheet ceiling. 71 CLNR, Multi Purpose Hall (Refer to 33538-161). **Asbestos Detected.**

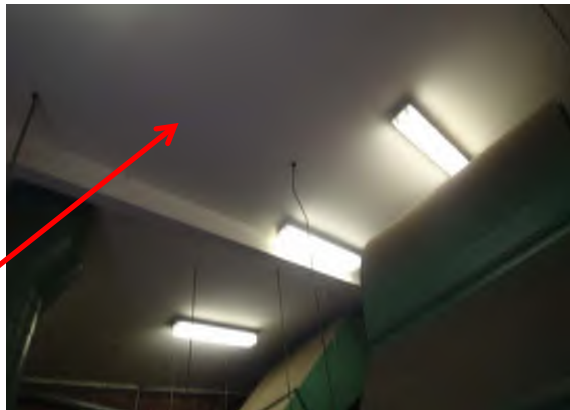
Photograph 21. Cement sheet ceiling. 76 & 77 Chair Store, Multi Purpose Hall (Refer to 33538-169). **Asbestos Detected.**

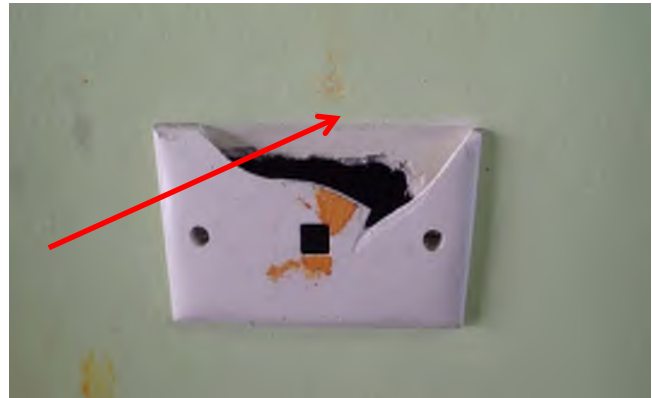
Photograph 22. Cement sheet walls. 79 PE Store, Multi Purpose Hall (Refer to 33538-128). **Asbestos Detected.**

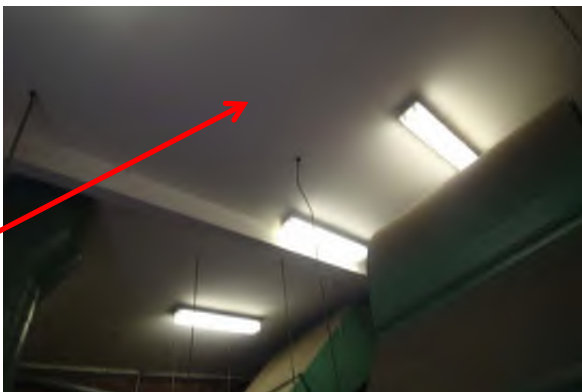
Photograph 23. Cement sheet ceiling. 79 PE Store, Multi Purpose Hall (Refer to 33538-129). **Asbestos Detected.**

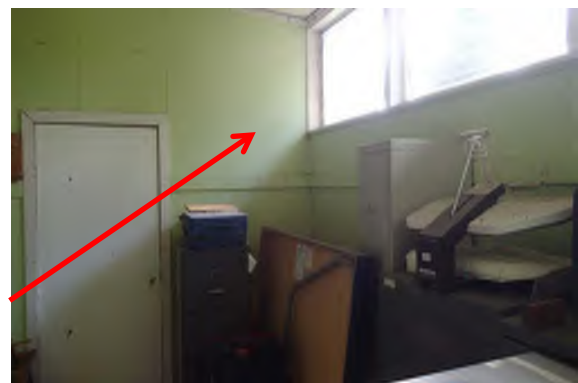
Photograph 24. Cement sheet walls. 80 PE Store, Multi Purpose Hall (Refer to 33538-170). **Asbestos Detected.**

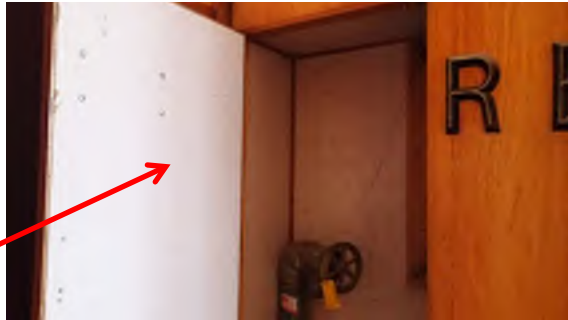
Photograph 25. Cement fire hose cupboard. 81 Hall, Multi Purpose Hall (Refer to 33538-158) **Asbestos Detected.**

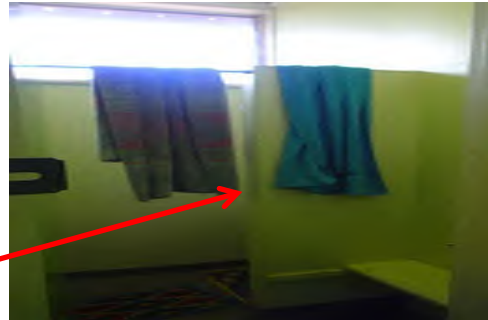
Photograph 26. Cement sheet cubicle partitions. 85 Male, Multi Purpose Hall (Refer to 33538-123). **Asbestos Detected.**

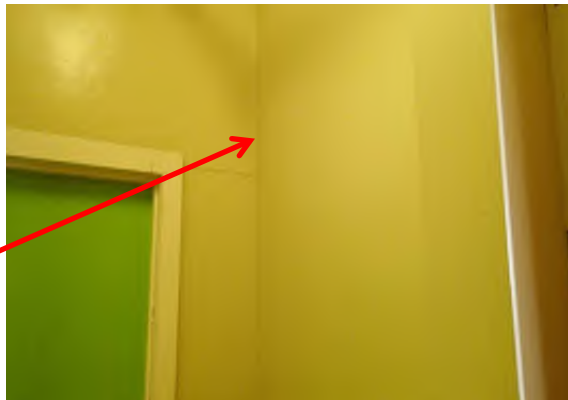
Photograph 27. Cement sheet walls. 88 Lobby, Multi Purpose Hall (Refer to 33538-125). **Asbestos Presumed.**

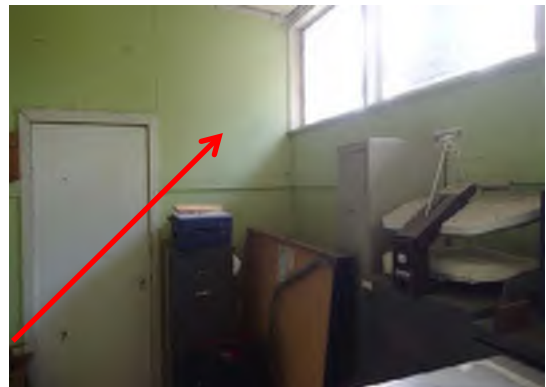
Photograph 28. Cement sheet walls. 91 Cloak, Multi Purpose Hall (Refer to 33538-110). **Asbestos Detected.**

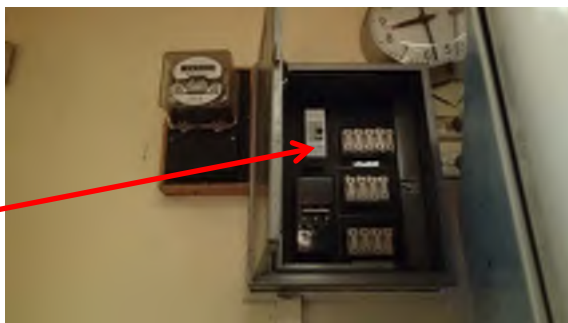
Photograph 29. Electrical backing board. 93 Servery, Multi Purpose Hall (Visual Observation). **Asbestos Presumed.**

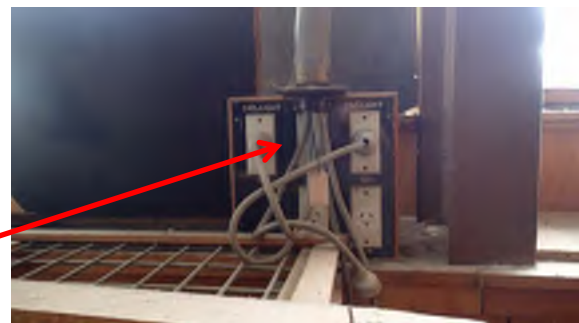
Photograph 30. Electrical backing board. 243 Store, Multi-purpose Hall (Visual Observation). **Asbestos Presumed.**

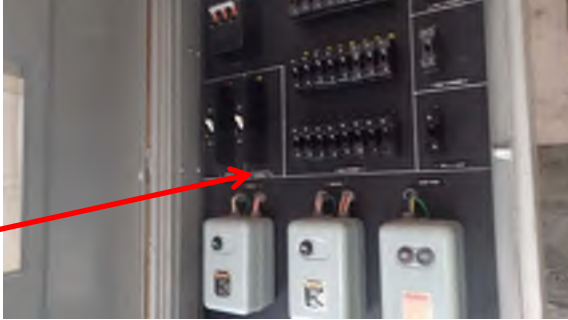
Photograph 31. Electrical backing board. 244 Store (sub level below stage area), Multi Purpose Hall (Visual Observation). **Asbestos Presumed.**

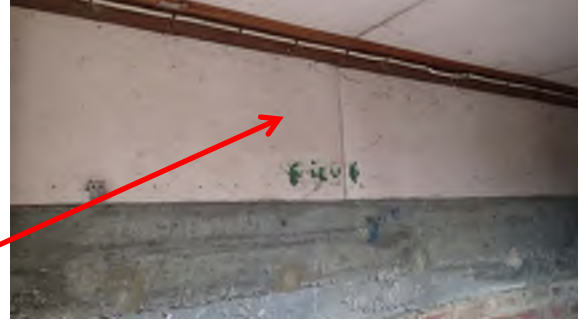
Photograph 32 Cement sheet walls. 244 Store (sub level below stage area), Multi Purpose Hall (Refer to 33538-183). **Asbestos Detected.**

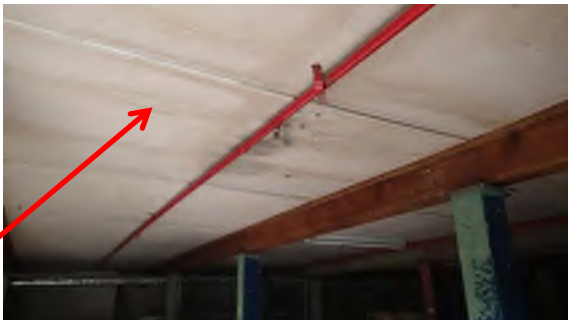
Photograph 33. Cement sheet ceiling. 244 Store (sub level below stage area), Multi Purpose Hall (Refer to 33538-182). **Asbestos Detected.**

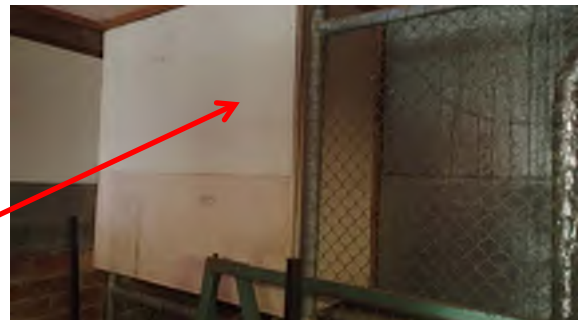
Photograph 34. Cement sheet partition walls. 244 Store (sub level below stage area), Multi Purpose Hall (Refer to 33538-180). **Asbestos Detected.**

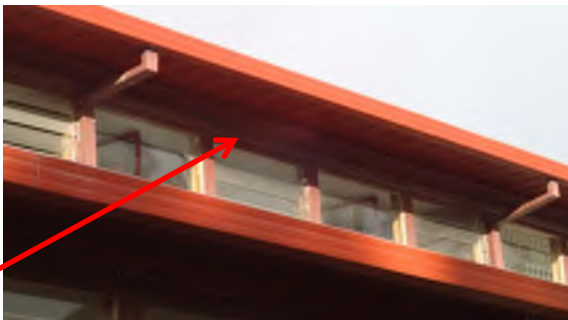
Photograph 35. Cement sheet eaves. External, Multi Purpose Hall (Visual Observation). **Asbestos Presumed.**

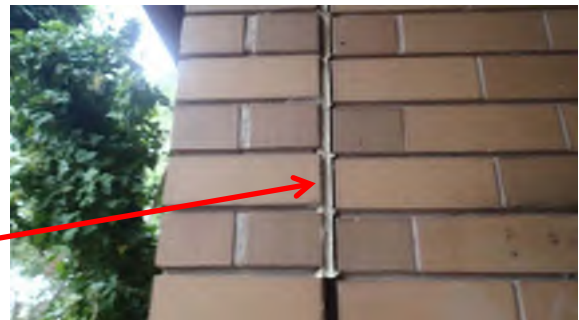
Photograph 36. Mastic wall expansion joint. External, Multi Purpose Hall (Refer to 33538-204). **Asbestos Detected.**

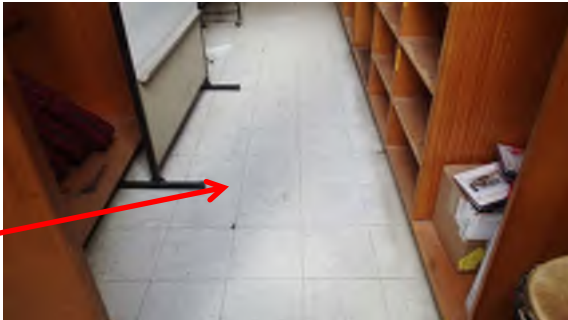
Photograph 37. Vinyl floor tiles. 99 Instruments Store, 37 Music Block. (Refer to 33538 - 186x). **Asbestos Detected**

Music Block													
ACM	Vinyl floor tiles	99 Instruments Store	37	Refer to 33538-186x	16 m ²	1	0	1	0	1	3	A4	White. Attached with black mastic/adhesive.
ACM	Vinyl floor tile adhesive	99 Instruments Store		Refer to 33538-186y	16 m ²	1	0	1	0	1	3	A4	
ACM	Vinyl floor tiles	102 Corridor	38	Refer to 33538-185x	12 m ²	1	0	1	1	1	4	A4	Localised damage adjacent 110 Practice Room. Attached with black mastic/adhesive. Encapsulate.
ACM	Vinyl floor tile adhesive	102 Corridor		Refer to 33538-185y	12 m ²	1	0	1	0	1	3	A4	
ACM	Vinyl floor tiles	103 Office	39	Refer to 33538-187x	6 m ²	1	0	1	0	1	3	A4	White. Attached with black mastic/adhesive.

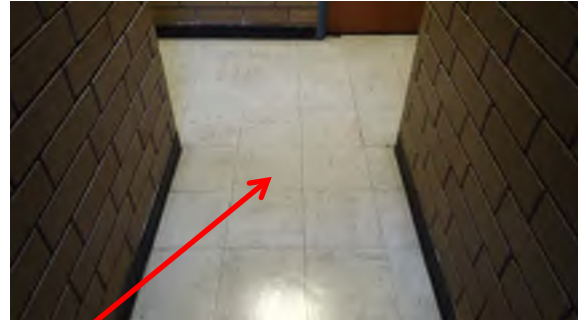
Photograph 38. Vinyl floor tiles . 102 Corridor, Music Block. (Refer to 33538-185x). **Asbestos Detected.**

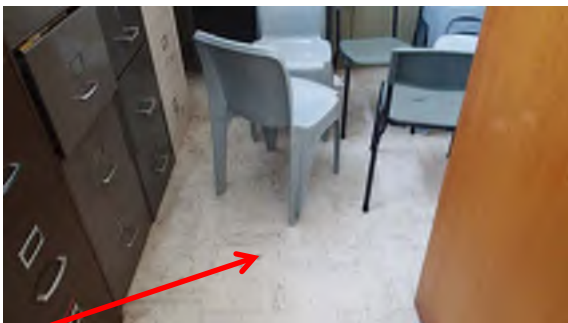
Photograph 39. Vinyl floor tiles. 103 Office, Music Block. (Refer to 33538-187x). **Asbestos Detected.**

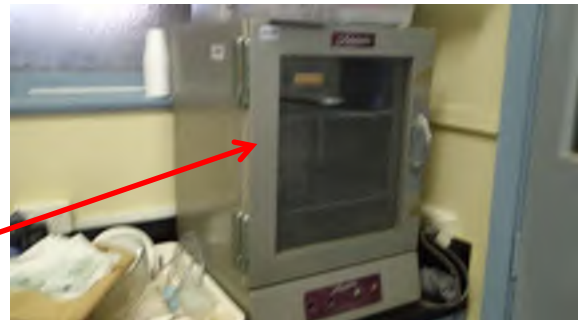
Photograph 40. Insulation to incubator. 30 Store, Science Wing (Visual Observation). **Asbestos Presumed.**

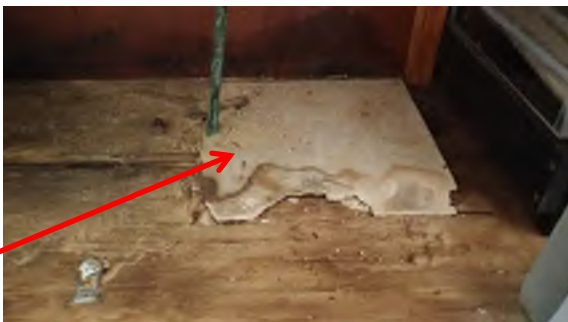
Photograph 41. Cement sheet panel and debris. 33 Science, Science Wing (Refer to 33538-37). **Asbestos Detected.**

ACM	Cement sheet panel and debris	33 Science	41	Refer to 33538-37	< 1 m ²	2	2	1	3	1	9	A2	Cement sheet repair panel to back of cupboard. Sink cupboard on south wall. Remove. Restrict access until removed. Refer to Appendix F.
ACM	Heat mats	33 Science	42	DA7318	10 units	1	1	1	2	1	6	A3	Stored in sealed cupboard. All suspect asbestos containing mats from 30 Store, 33 Science, 35 Store and 37 Science were stored in this area. Remove. Restrict access until removed. See Appendix F.
ACM	Mastic to AC ductwork	35 Store		DA7316	< 1 m ²	1	0	1	1	1	4	A4	Mastic to AC duct flange joining. Presume material to be in same application throughout the building.
ACM	Millboard lining to hotplates	35 Store	43	DA7314	3 units	1	2	2	1	2	8	A2	Lining to hotplates (x3). Stored in sealed cupboard. All portable suspect asbestos containing materials from 30 Store, 33 Science, 35 Store and 37 Science were stored in sealed cupboard - 33 Science. Remove. Restrict access until removed. See Appendix F.

33538/37	Science Wing - Science 33 - cement sheet repair panel, floor area under sink - brown cement sheet material - 1 cm ³	Amosite (Brown Asbestos)
33538/38	Science Wing - Science 33 - cement sheet heat mats - grey cement sheet material - <1 cm ³	No Asbestos Fibres Detected
33538/39	Science Wing - Store 35 - cement sheet heat mats - grey cement sheet material - 1 cm ³	Chrysotile (White Asbestos)
33538/40	Science Wing - Science 37 - cement sheet heat mats - grey cement sheet material - 1 cm ³	No Asbestos Fibres Detected
33538/41	Science Wing - Store 30 - cement sheet lined cupboard - grey cement sheet material - <1 cm ³	No Asbestos Fibres Detected
33538/42	Science Wing - Store 30 - rope seal to flammable liquids cupboard - white fibrous woven material - <1 cm ³	No Asbestos Fibres Detected

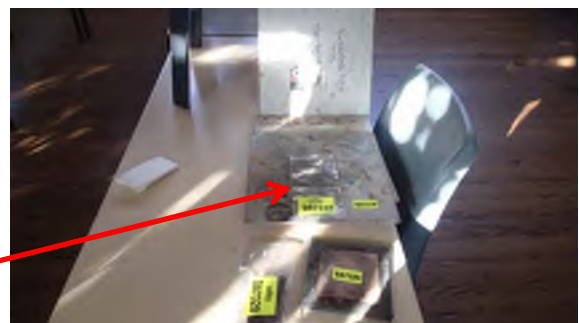
Photograph 42. Heat mats. 33 Science, Science Wing (DA7318). **Asebstos Detected.**

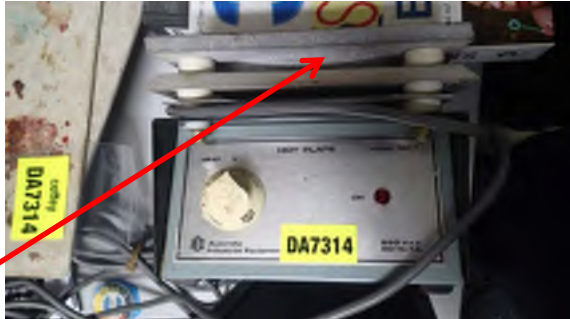
Photograph 43. Millboard lining to hotplate. 35 Store, Science Wing (Refer to 33538-39). **Asbestos Detected.**

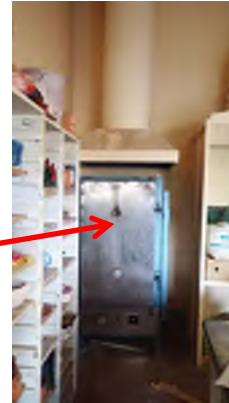
Photograph 44. Internal lining to kiln. 3 Clay Store, Trade Wing (Visual Observation). **Asbestos Presumed.**

Trade Wing													
ACM	Cement sheet ceiling	8 Corridor		Refer to 33538-211	50 m ²	1	1	1	0	0	3	A4	Painted cream.
ACM	Internal lining to kiln	3 Clay Store	44	Visual Observation	1 unit	2	1	1	0	1	5	A3	No access to sample without damage. Asbestos presumed.
ACM	Cement sheet eaves	External		Refer to 33538-243, 279, 280, 285	40 lm	2	1	1	0	0	4	A4	Painted yellow.
ACM	Cement sheet clear storey eaves	External		Refer to 33538-245 & 246	40 lm	2	1	1	0	0	4	A4	Painted white.
No access was gained within and behind walls, floors, subfloors, tiles, urinals, cavities, ceiling voids, plant/machinery, live electrics or to heights above 3m. Limited access below floor coverings, behind wall coverings and where large amounts of stored items were present. These areas may require further investigation.

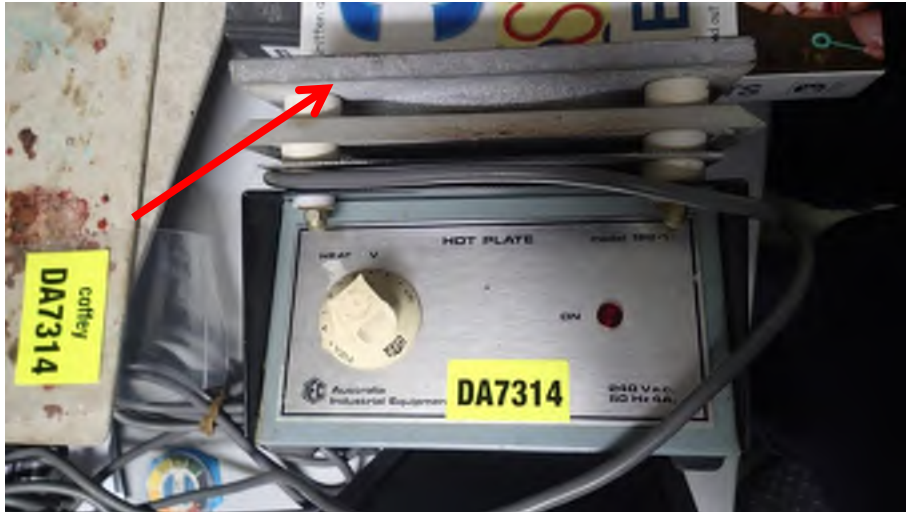
Photograph 1. Millboard lining to hotplate. 33 Science , Science Wing (DA7314). **Asbestos detected.**

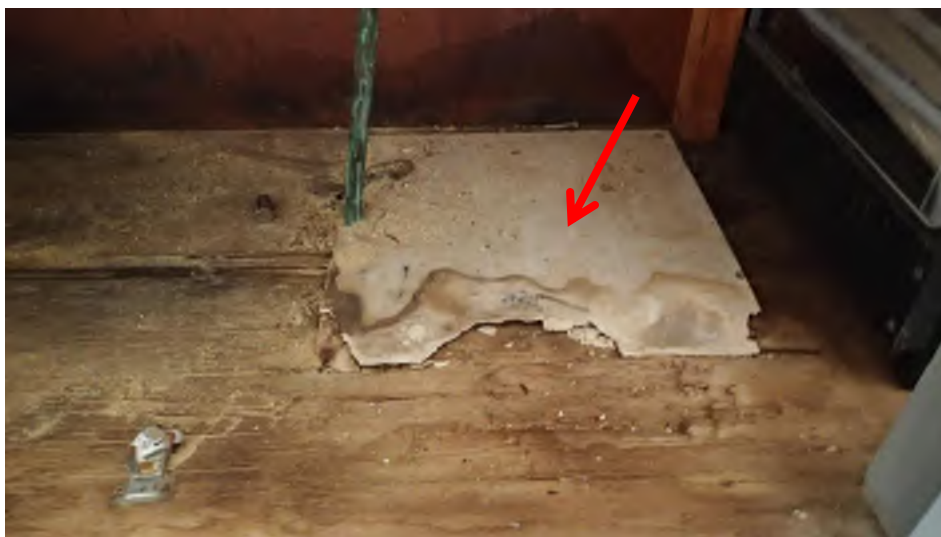
Photograph 2. Cement sheet debris, cupboard 33 Science, Science Wing (Refer to previous audit). **Asbestos detected.**

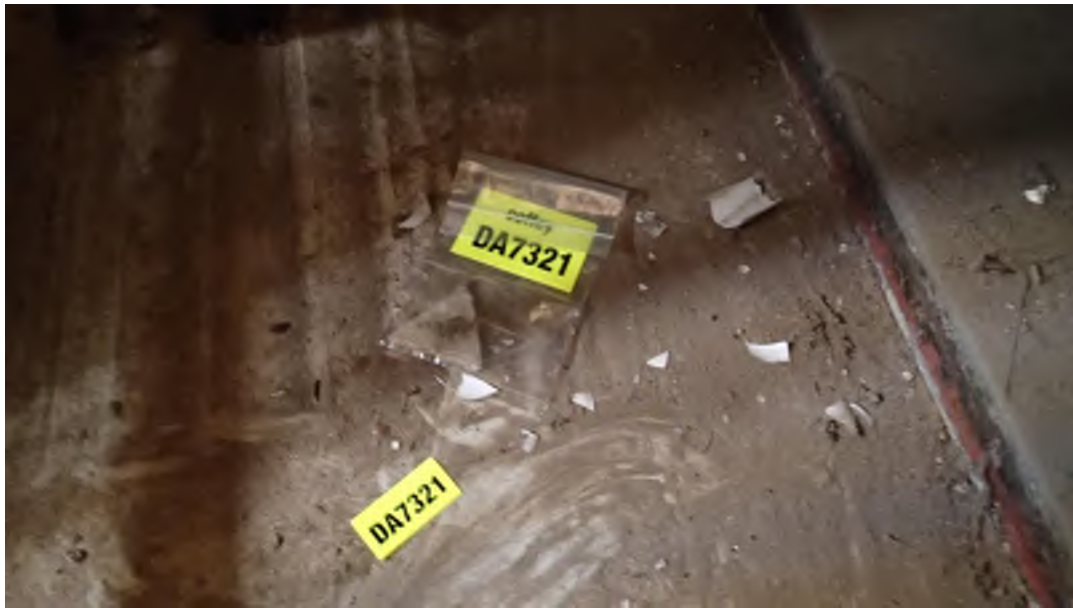
Photograph 3: Cement sheet debris. 264 Store, Commerce Wing (DA7321). **Asbestos detected.**

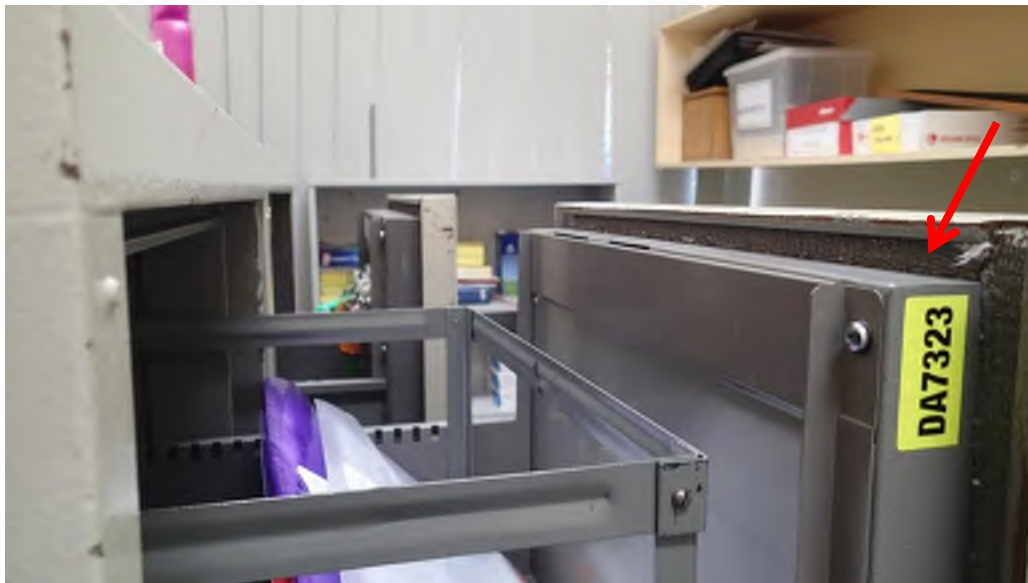
Photograph 4: Rope lining to filing cabinet. 57 Resource, Commerce Wing (DA7323) **Asbestos detected.**

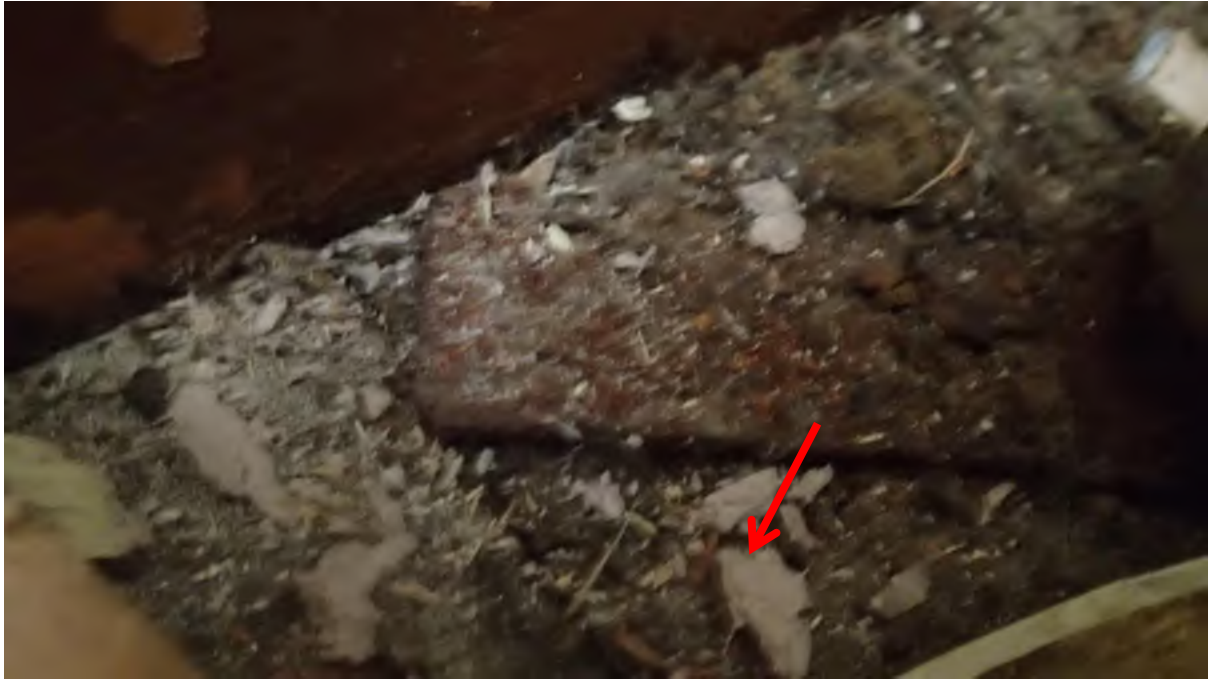
Photograph 5: Cement sheet debris. 64 Prop Store, Multi-purpose hall (DA7325) **Asbestos detected.**
