ASBESTOS MATERIALS ASSESSMENT

Sunshine College Campus 4

Northumberland Road

Subject: **Asbestos Materials Assessment of Sunshine College Campus 4, Northumberland Road, Sunshine North, VIC 3020 (Site 8790)**

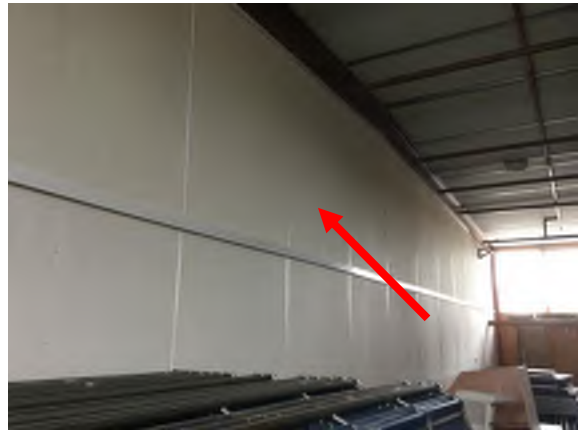
Photograph 5

Sample No. Refer 33538/147

Asbestos detected

Cement sheet partition wall(s)

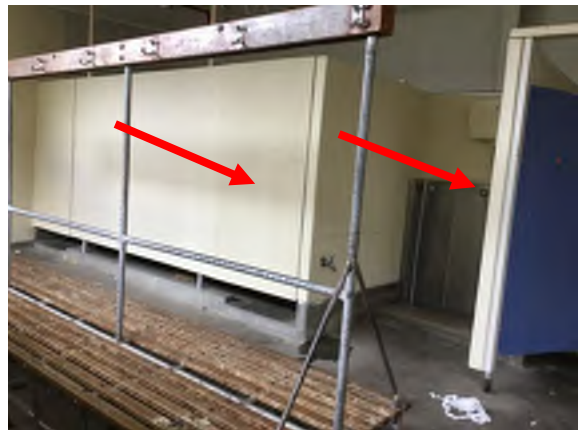
Photograph 9

Sample No. Refer 33538/137

Asbestos detected

Cement sheet cubicle partition(s)

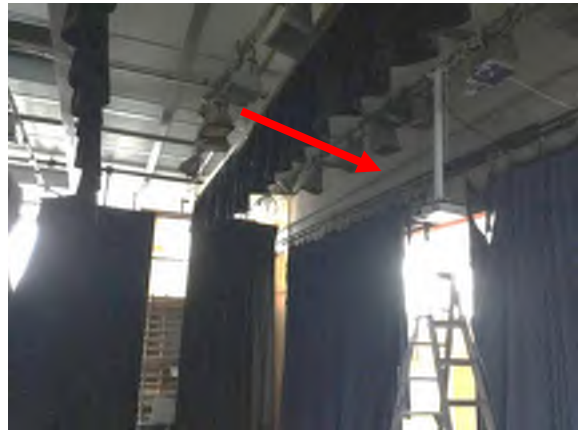
Photograph 14

Sample No. FI0297

Asbestos detected

Cement sheet wall(s)

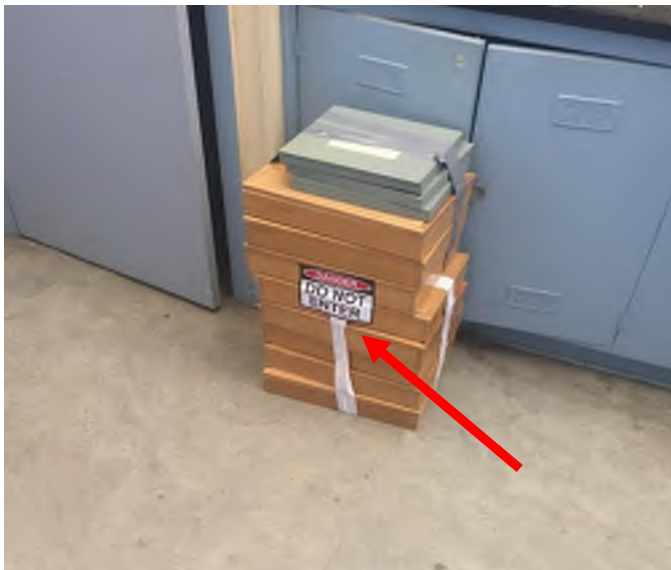
Photograph 1. Mineral Kits, 27 Science, Science Wing, (Visual Observation). **Asbestos suspected.**

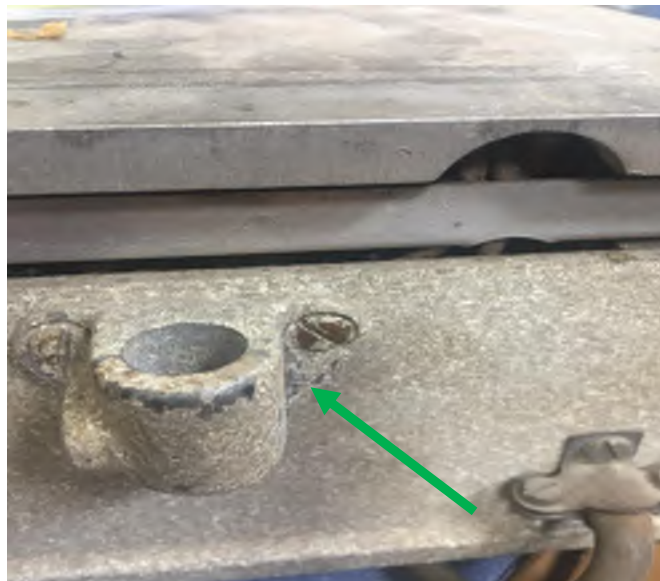
Photograph 2. Internal Insulation to hot plate, 27 Science, Science Wing; (FI0306). **No asbestos detected.**

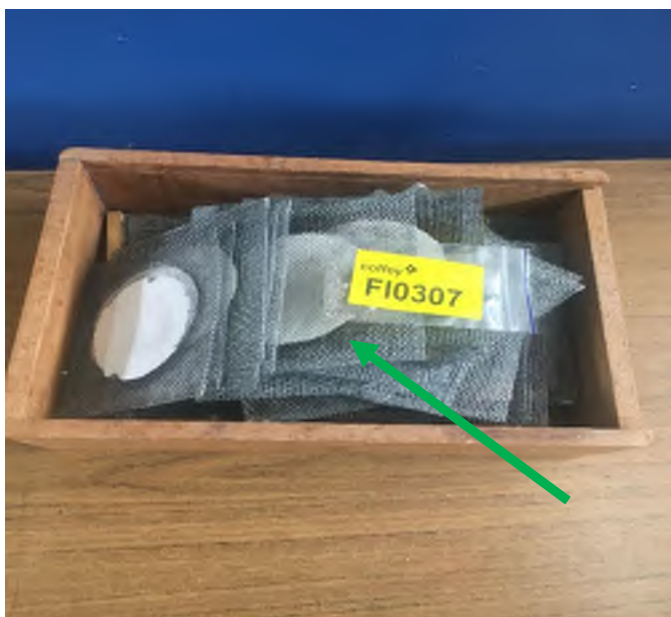
Photograph 3. Gauze Mats, 27 Science, Science Wing; (FI0307). **No asbestos detected.**
