ASBESTOS MATERIALS ASSESSMENT

Sunshine College Campus 4

Northumberland Road

Subject: **Asbestos Materials Assessment of Sunshine College Campus 4, Northumberland Road, Sunshine North, VIC 3020 (Site 8790)**

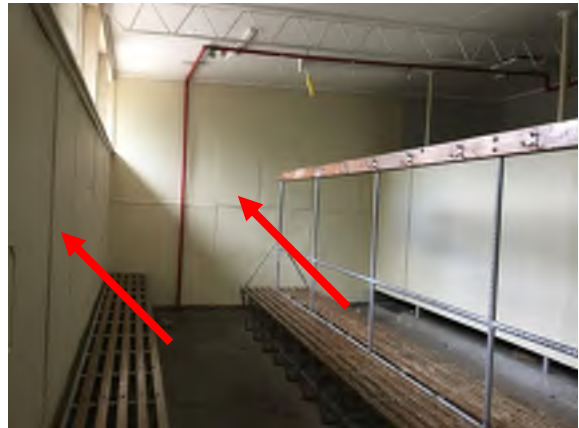
Photograph 8

Asbestos detected

Cement sheet cubicle partition(s)

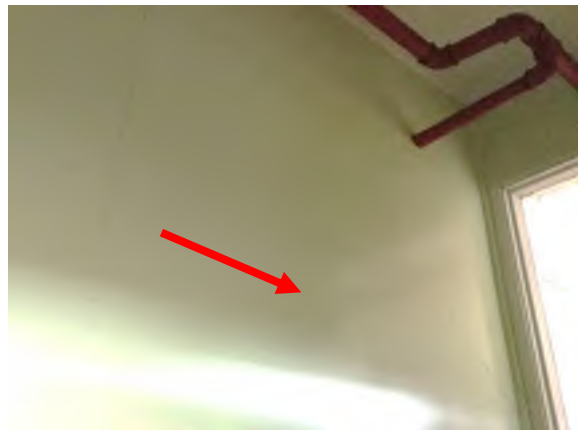
Photograph 15

Asbestos detected

Cement sheet ceiling(s)

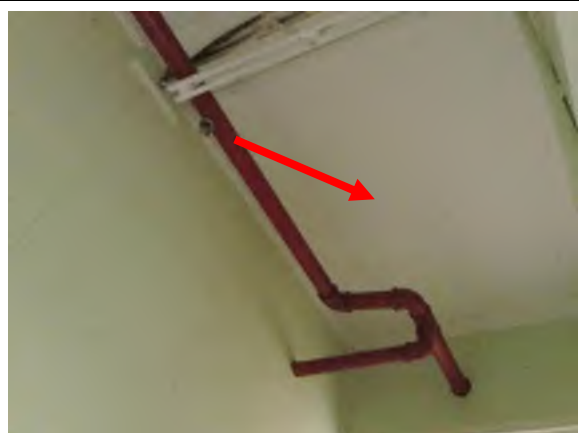
Photograph 16

Asbestos detected

Cement sheet wall(s)

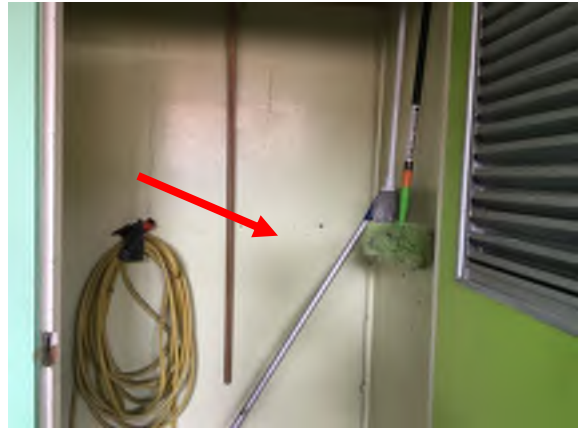
Photograph 17

Asbestos detected

Cement sheet ceiling(s)

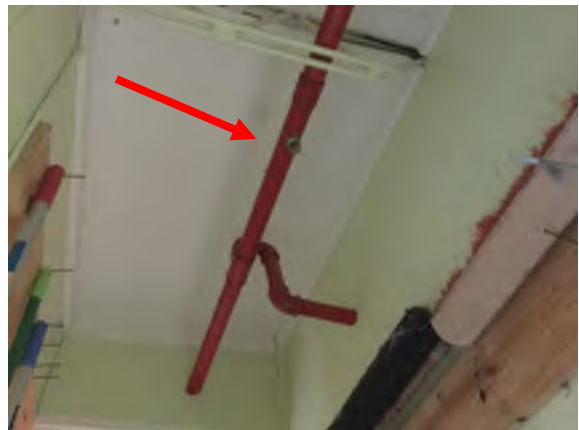
Photograph 18

Asbestos detected

Cement sheet infill panel(s)

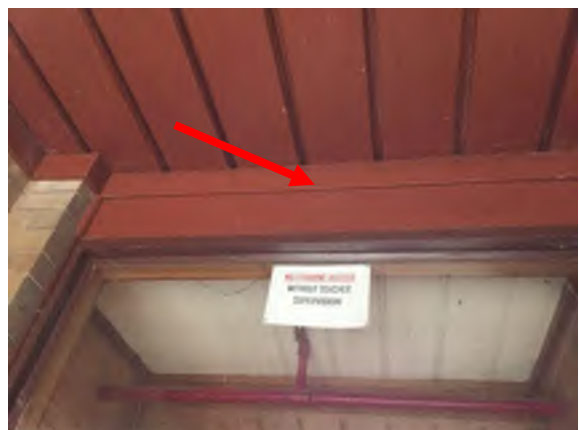
Photograph 19

Asbestos detected

Cement sheet infill panel(s)

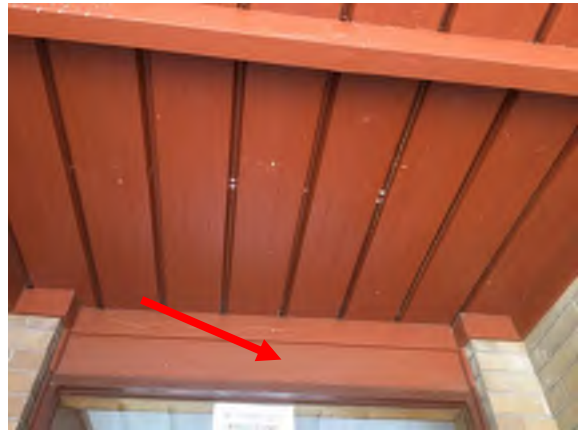
Photograph 20

Asbestos detected

Cement sheet ceiling(s)

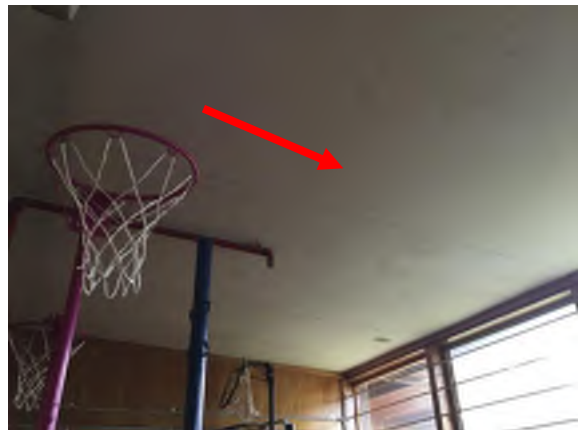
Photograph 21

Asbestos detected

Cement sheet ceiling(s)

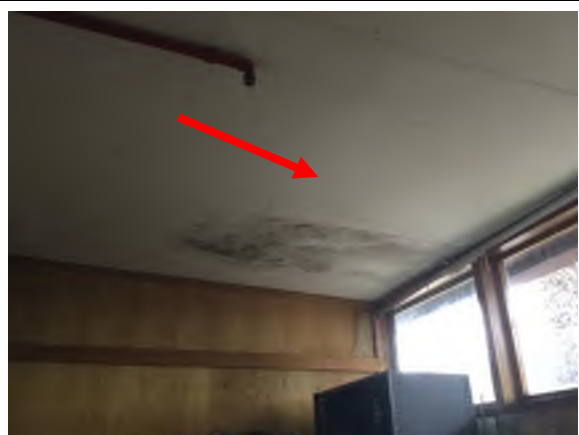
Photograph 22

Asbestos detected

Cement sheet ceiling(s)

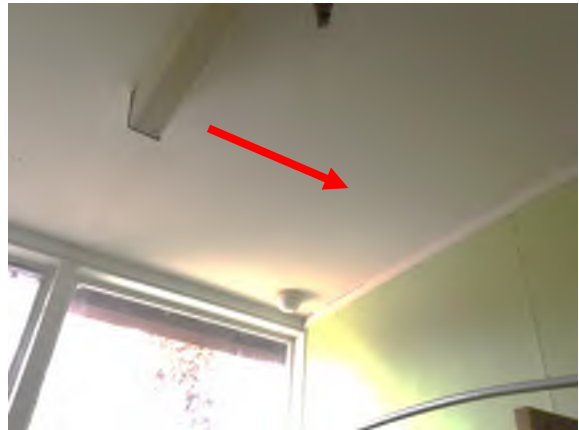
Photograph 23

Asbestos detected

Cement sheet wall(s)

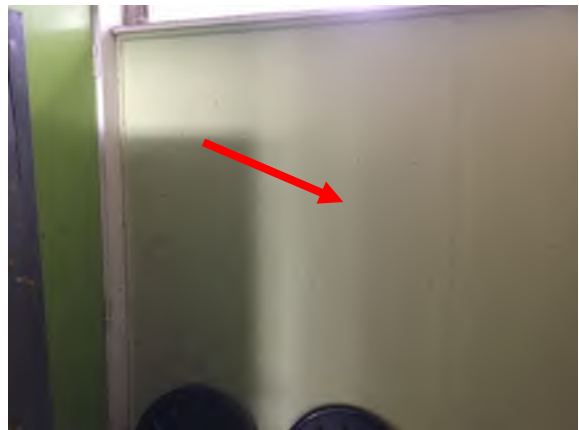
Photograph 24

Asbestos detected

Cement sheet wall(s)

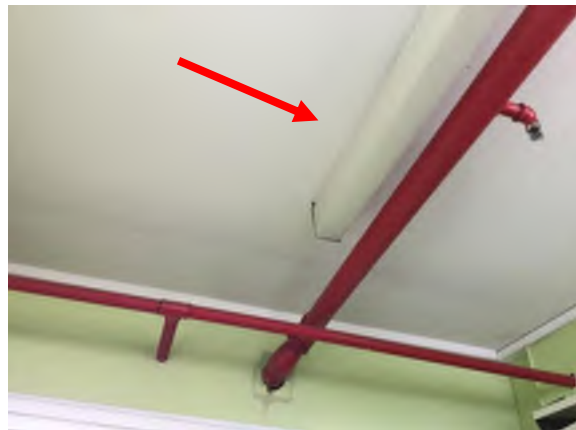
Photograph 26

Asbestos detected

Cement sheet ceiling(s)

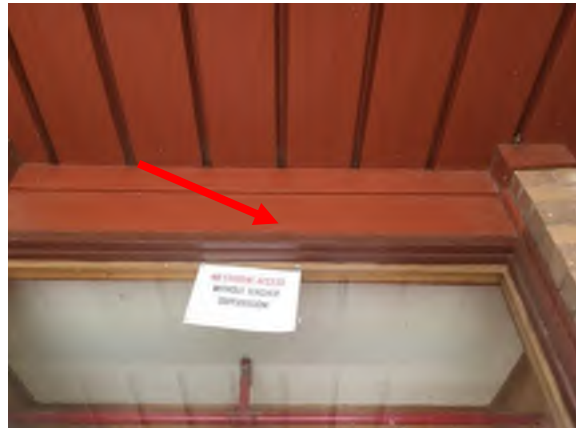
Photograph 29

Asbestos detected

Cement sheet ceiling(s)

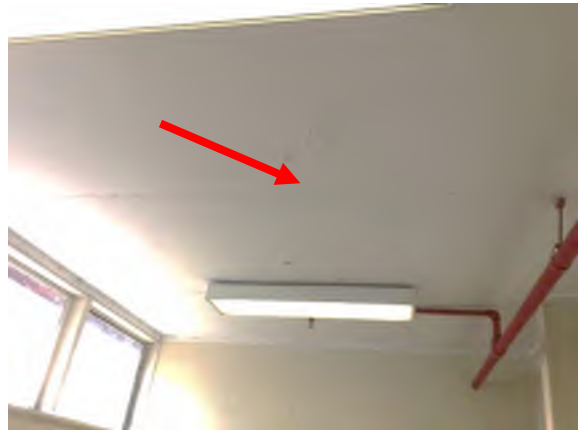
Photograph 35

Asbestos detected

Cement sheet wall(s)

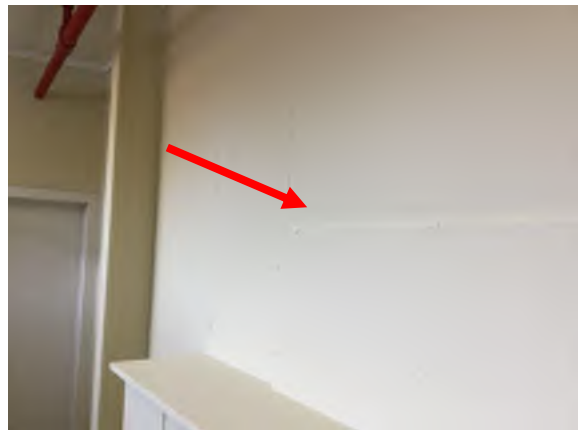
Photograph 36

Asbestos detected

Cement sheet wall(s)

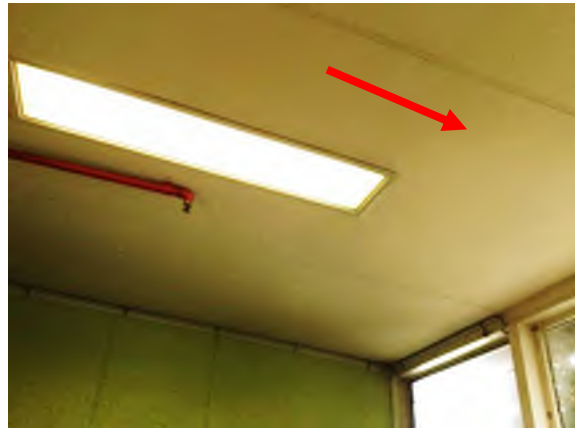
Photograph 47

Asbestos detected

Cement sheet ceiling(s)

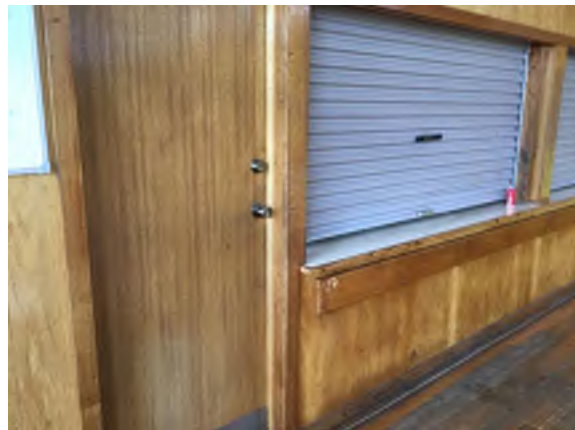
Photograph 48

Asbestos detected

Electrical backing board(s)

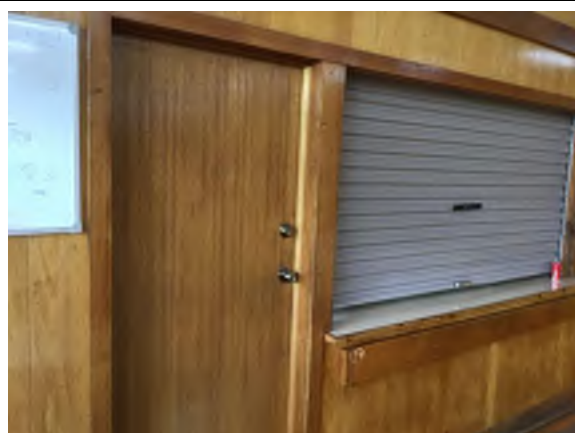
Photograph 49

Asbestos presumed

Cement sheet wall(s)

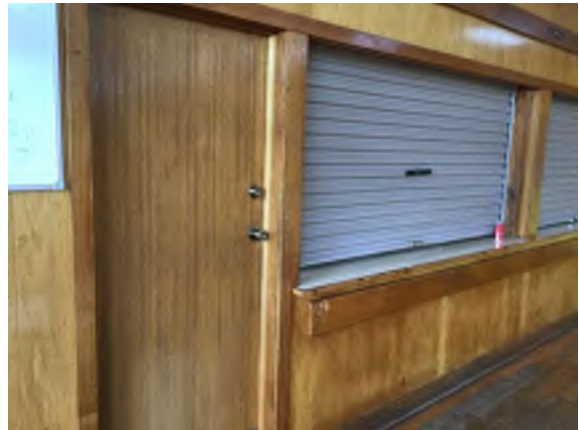
Photograph 50

Asbestos detected

Cement sheet wall(s)

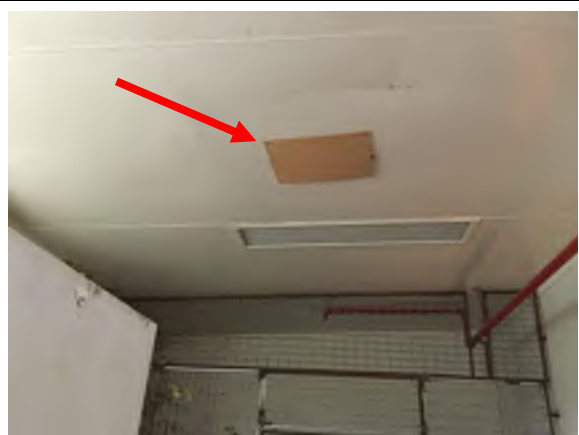
Photograph 52

Asbestos detected

Cement sheet infill panel(s)

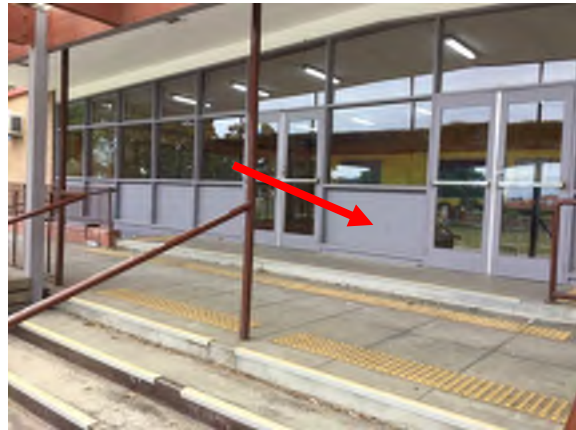
Photograph 53

Cement sheet ceiling(s)

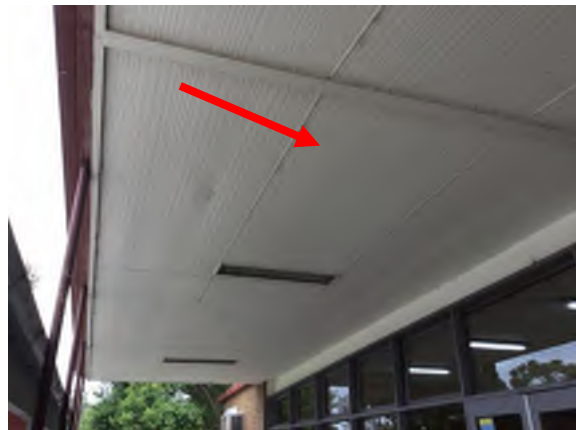
Photograph 54

Cement sheet infill panel(s)

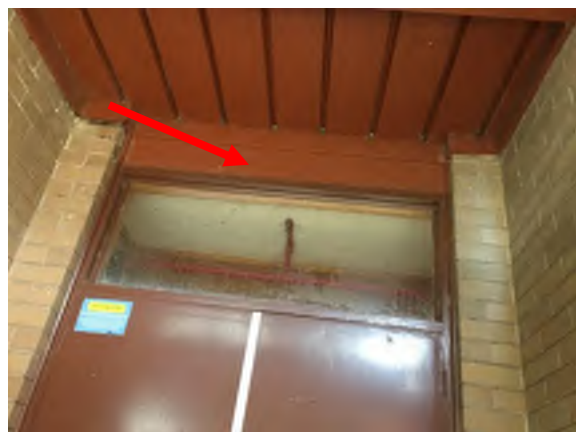
Photograph 55

Electrical backing board(s)

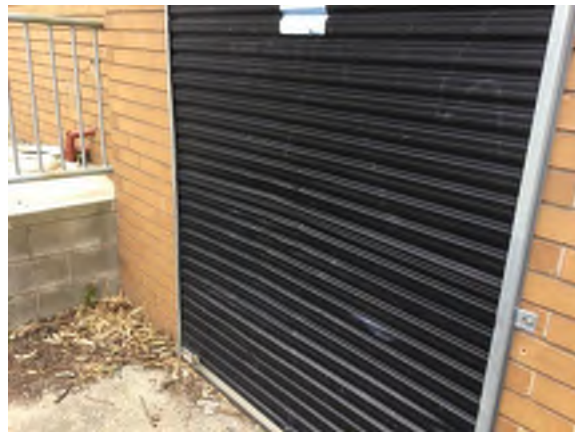
Photograph 56

Cement sheet wall(s)

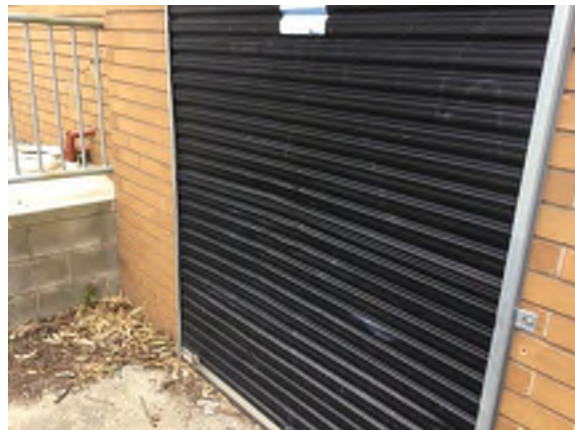
Photograph 57

Cement sheet ceiling(s)

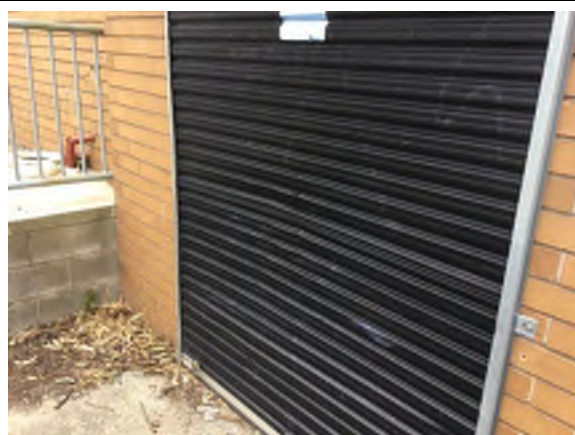
Photograph 58

Cement sheet upper wall(s)

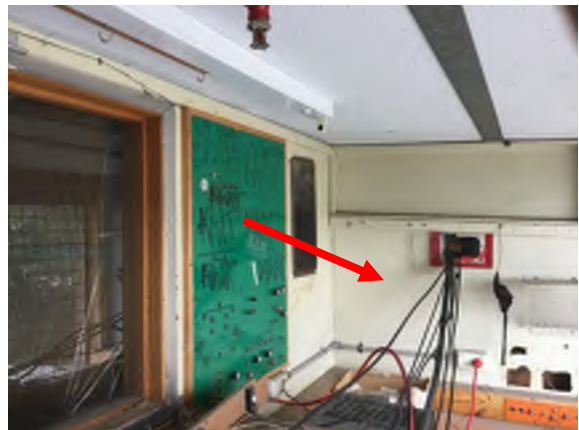
Photograph 59

Cement sheet infill panel(s)

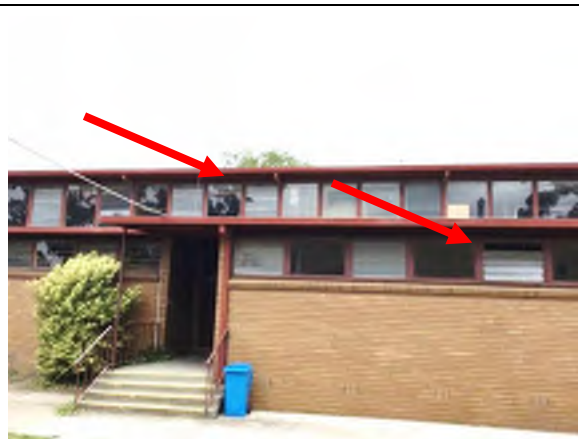
Photograph 60

Mastic to block work

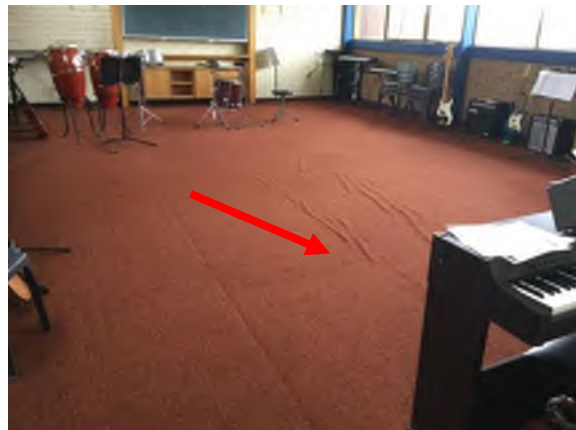
Photograph 63

Vinyl floor tiles

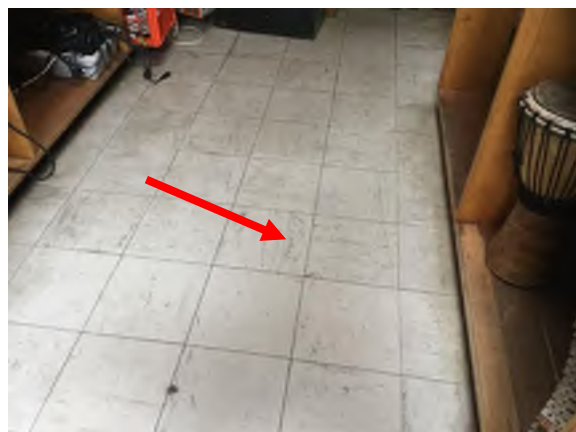
Photograph 64

Adhesive under vinyl floor sheet/tiles

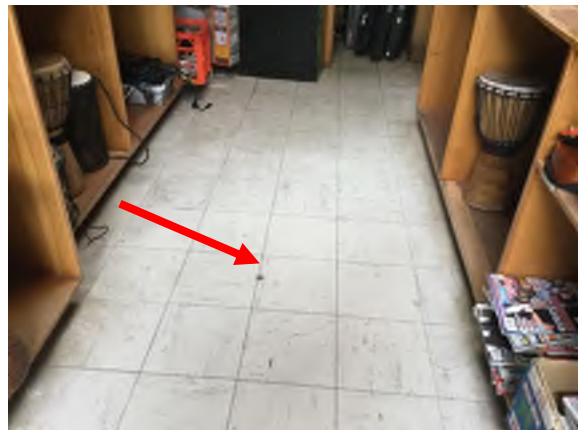
Photograph 65

Vinyl floor tiles

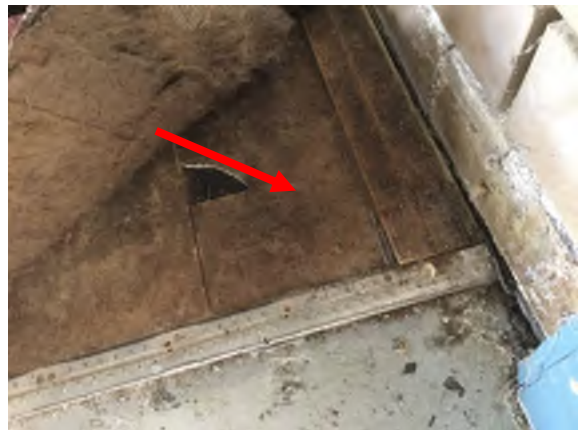
Photograph 66

Adhesive under vinyl floor sheet/tiles

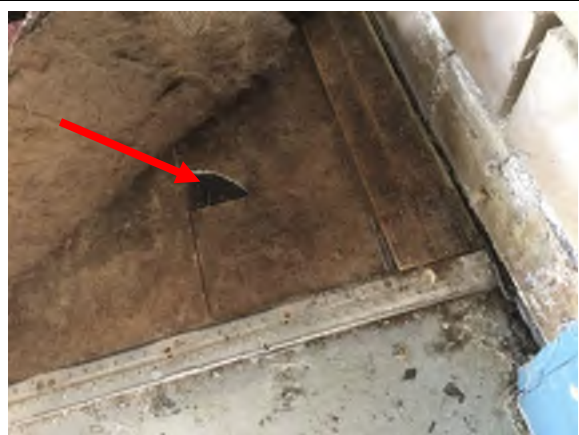
Photograph 67

Adhesive under vinyl floor sheet/tiles

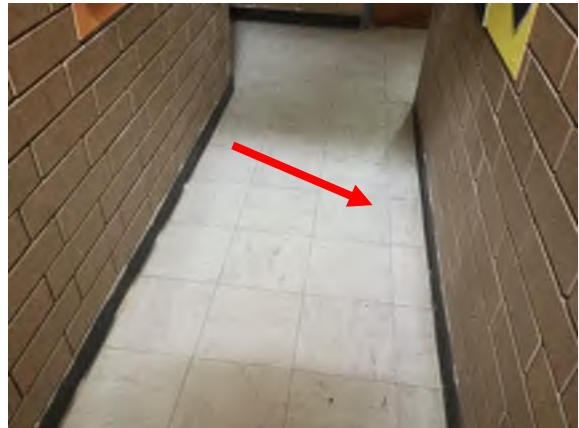
Photograph 68

Vinyl tiles

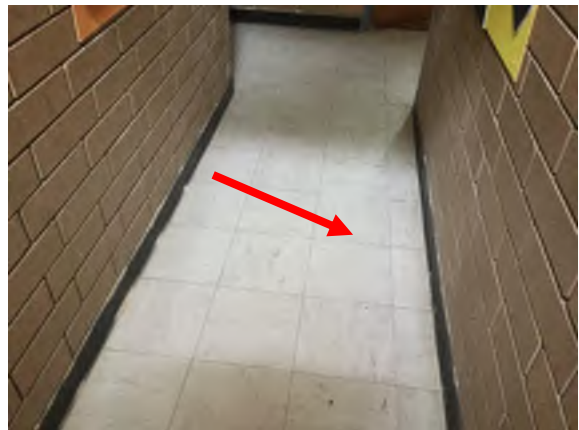
Photograph 69

Vinyl tiles

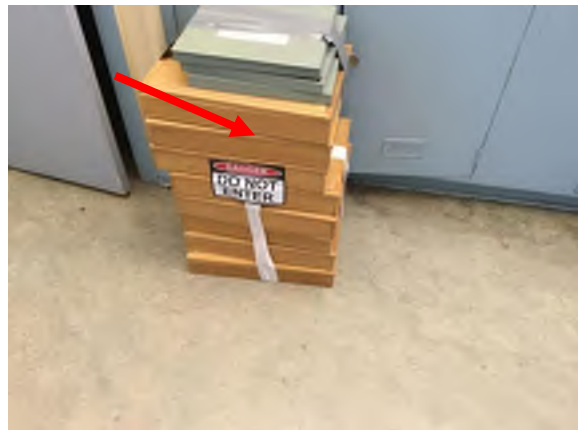
Photograph 75

Internal insulation to incubator(s)

ACM	Internal insulation to incubator(s)	30 Store	75	Visual Observation	1 unit	1	1	2	0	0	4	A4	Labmaster. No internal access without significant damage. Asbestos presumed.
ACM	Mastic to duct work joints(s)	35 Store	76	Refer DA7316	1 Lm	1	0	1	1	0	3	A4	
ACM	Cement sheet eaves	External	77	Refer 33538/248, 299- 300, 303-307	220 m ²	2	1	1	0	0	4	A4	
ACM	Cement sheet porch ceiling(s)	External	78	Refer 33538/304 & 306	4 m ²	2	1	1	0	0	4	A4	East and West of 131 Covered Way.
No access was gained within and behind walls, floors, subfloors, tiles, urinals, cavities, ceiling voids, plant/machinery, live electrics or to heights above 3m. Limited access below floor coverings, behind wall coverings and where large amounts of stored units were present. These areas may require further investigation.													
Trade Wing													
ACM	Internal insulation to kiln(s)	3 Clay Store	79	Visual Observation	1 unit	1	1	2	0	0	4	A4	Jetflow. No internal access without significant damage. Asbestos presumed.

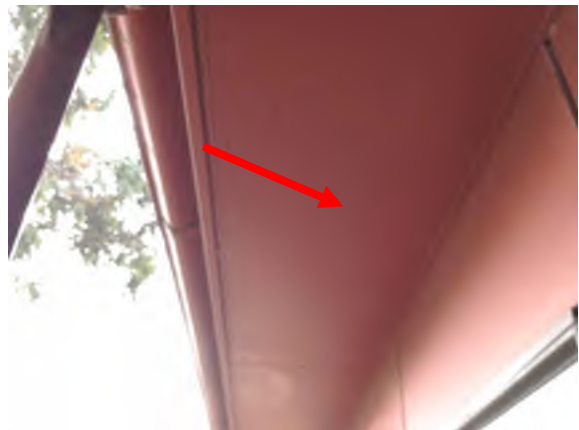
Photograph 78

Cement sheet porch ceiling(s)
